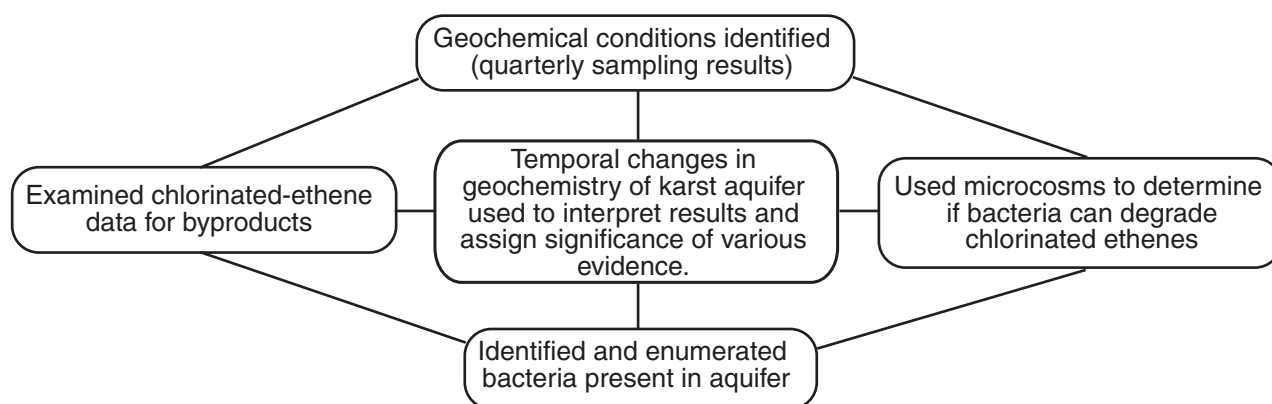
Figure 29. Lines of evidence needed to evaluate biodegradation of chlorinated ethenes in the karst aquifer.
